East Meath - North Dublin Grid Upgrade Environmental Impact Assessment Report (EIAR): Volume 3

Preface and Contents

EirGrid

March 2024

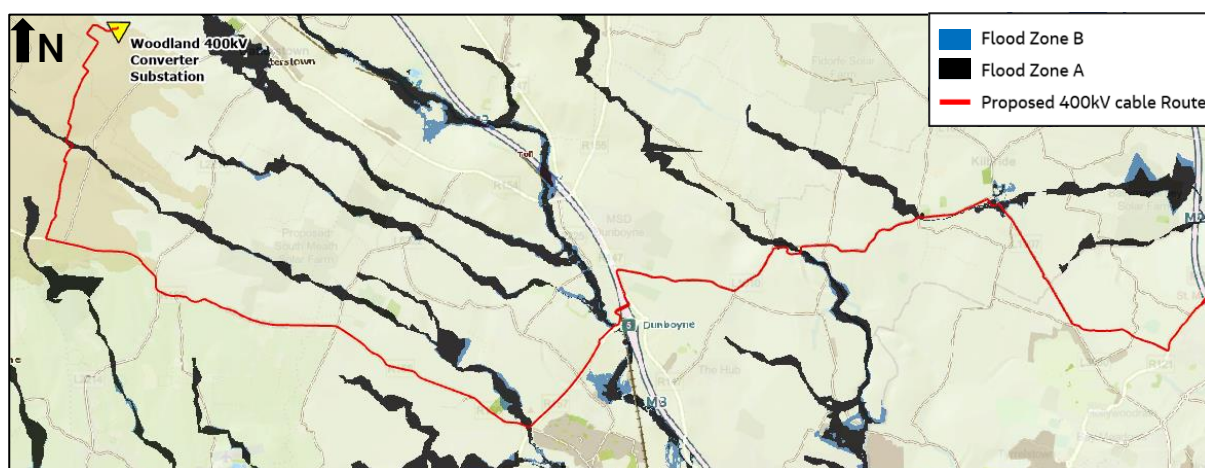
Image 4.14: Extract of Flood Zones A and B from MCDP (MCC 2021)

As mentioned in Section 2.4, JBA Consulting was commissioned by Meath County Council in November 2011 to undertake a SFRA. This study informed the MCDP (MCC 2021). As depicted in Image 4.14, the majority of the Proposed Development will be located in Flood Zone C (as defined in Section 3.1), except for local crossings with Flood Zone B and A sites.

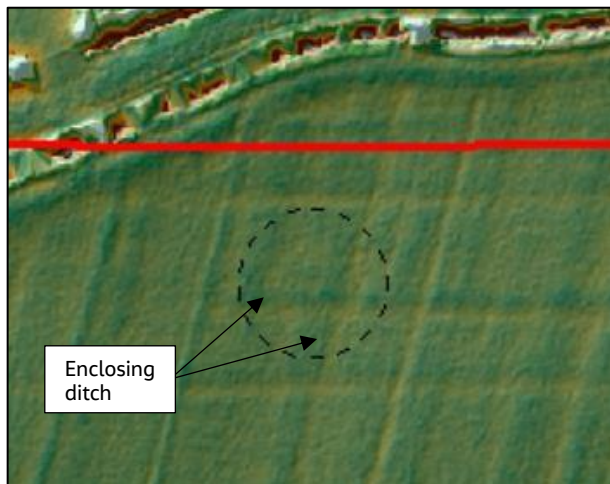
Image 4.8: A very ephemeral circular feature (LI_65), defined by a possible circular enclosing ditch, measuring approximately 17m in diameter and interpreted as a possible enclosure in the townland of Vesingtown.

Simple Local Relief Model (50% transparency) over Single Direction Hillshade Model: DTM azimuth 315° and altitude 10°.

Image 4.8: A very ephemeral circular feature (LI_65), defined by a possible circular enclosing ditch, measuring approximately 17m in diameter and interpreted as a possible enclosure in Vesingtown.

Eight possible previously unrecorded enclosures (LI_31 (Image 4.2), LI_34 (Image 4.3), LI_40 (Image 4.4), LI_53 (Image 4.5), LI_54 (Image 4.6), LI_63 (Image 4.7) LI_65 (Image 4.8), and LI_71 (Image 4.9)) were also identified from the LiDAR data in the townlands of Kinoristown, Stokestown, Irishtown, Forest Great, Cloghran, Vesingtown, Harlockstown and Ballystrahan. The enclosures identified within the study area are circular in shape and defined by ditches, banks, or a combination of ditches and banks, and range in diameter from approximately 17m to 88m. LI_63 in Harlockstown (Figure 8) is a rectangular enclosure, measuring approximately 18m by 10m .

- Eight possible enclosures (LI_31 (Image 4.2), LI_34 (Image 4.3), LI_40 (Image 4.4), LI_53 (Image 4.5), LI_54 (Image 4.6), LI_63 (Image 4.7), LI_65 (Image 4.8), and LI_71 (Image 4.9)) of unknown date and function; and
- Six possible palaeochannels in Harlockstown (LI_18), Dunboyne (LI_24), Pace (LI_27 (Image 4.16) and LI_69 (Image 4.17)), Nuttstown (LI_36), and Cloghran (LI_58).

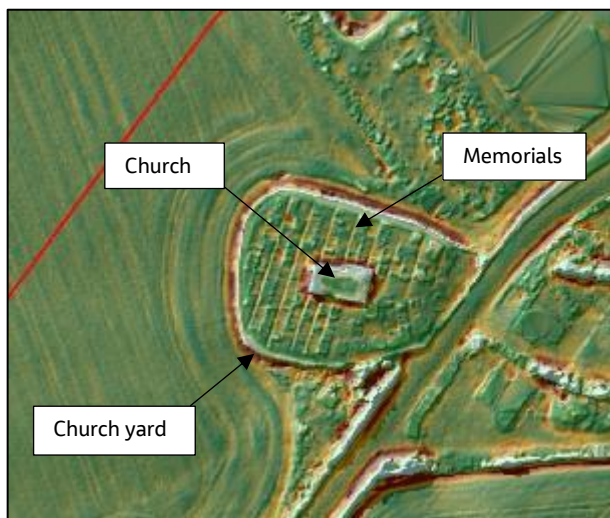
Image 4.14: St. Brigid's Church & Graveyard (LI_43; Also AY_23, AY_24 and AH_06; DU011-039001, DU011-039002 and RPS 660) in Ward Lower comprising a raised sub-circular enclosed church yard, with memorials, surrounding a rectangular church building.

Simple Local Relief Model (50% transparency) over Single Direction Hillshade Model: DTM azimuth 315° and altitude 10°.

Image 4.14: St. Brigid's Church & Graveyard (LI_43; Also AY_23, AY_24 and AH_06; DU011-039001, DU011-039002 and RPS 660) in Ward Lower comprising a raised sub-circular enclosed church yard, with memorials, surrounding a rectangular church building.

St. Brigid's Church and Graveyard (LI_43; Image 4.14) is recorded on the RMP (DU011-039001 and DU011-039001) and the Record of Protected Structures (RPS) (RPS 660) and was identified at Step 4 (AY_23, AY_24 and AH_07). Surrounded by a wall, the church yard comprises a raised sub-circular area surrounding the ruins of a rectangular medieval parish church with rows of headstones dating to the 19th and 20th Centuries. Both the church yard, headstones and footings of the church were visible on the LiDAR data (Image 4.14).

In addition, the remains of a medieval parish church and associated walled church yard (LI_43; Image 4.14) in Ward Lower were identified within the study area. LI_43 is a Recorded Monument (DU011-039001 and DU011-039002) and Protected Structure (RPS 660), and is depicted on historic Ordnance Survey mapping (1908) as 'in ruins'.

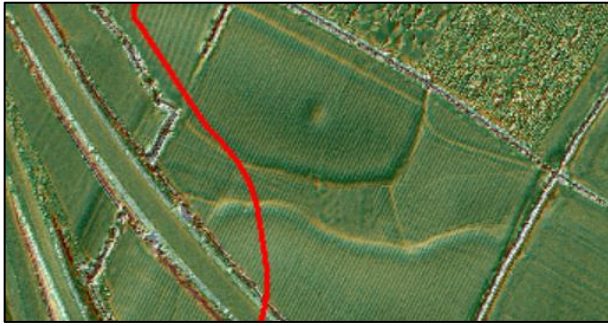
Image 4.16: A wide curvi-linear channel (LI_27) in Pace, interpreted as a possible palaeochannel, located near the River Tolka; however, not depicted on historic or modern mapping.

Single Direction Hillshade Model: DTM azimuth 315° and altitude 45°.

Image 4.16: A wide curvi-linear channel (LI_27) in Pace, interpreted as a possible palaeochannel, located near the River Tolka; however, not depicted on historic or modern mapping.

Six possible palaeochannels (LI_18, LI_24, LI_27 (Image 4.16), LI_36, LI_58, and LI_69 (Image 4.17)) were also identified from LiDAR data. These constraints comprise channels of former watercourses, including possible river terraces and levees. While LI_69 (Image 4.17) is depicted on historic Ordnance Survey mapping (1837) as the meandering channel of the River Tolka prior to the channel being straightened, the others do not reflect the channels of known watercourses shown on historic or modern mapping and therefore are likely to be former watercourses that have been filled or buried.

A total of six possible palaeochannels (LI_18, LI_24, LI_27 (Figure 17), LI_36, LI_58, and LI_69 (Image 4.17)) were identified within the study area. These areas may comprise locations of higher archaeological potential as watercourses were often the focus of human activity and there is the potential for votive offerings, objects apparently deposited for religious reasons, in rivers, and areas of alluvium have the potential to preserve previously unknown archaeological remains, including paleoenvironmental and organic materials.

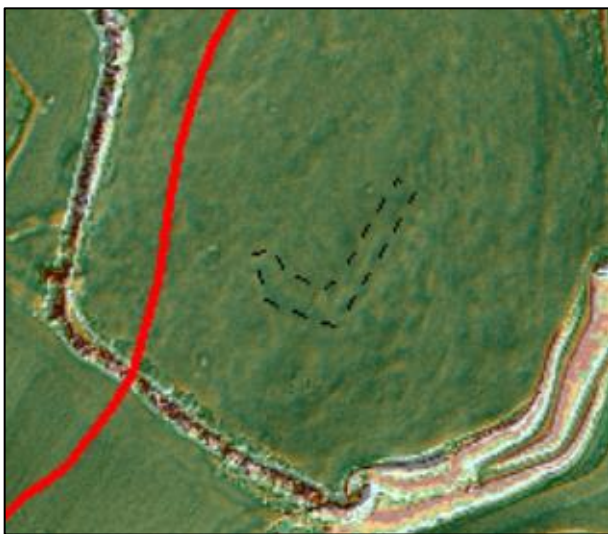
Image 4.17: A narrow irregular channel to the north-east of the River Tolka in Pace (LI_69). Corresponds with the meandering course of the river depicted on First Edition Ordnance Survey mapping (1837) then as the former channel on later editions (1911).

Simple Local Relief Model (50% transparency) over Single Direction Hillshade Model: DTM azimuth 315° and altitude 10°.

Image 4.17: A narrow irregular channel to the north-east of the River Tolka in Pace (LI_69). Corresponds with the meandering course of the river depicted on First Edition Ordnance Survey mapping (1837) then as the former channel on later editions (1911).

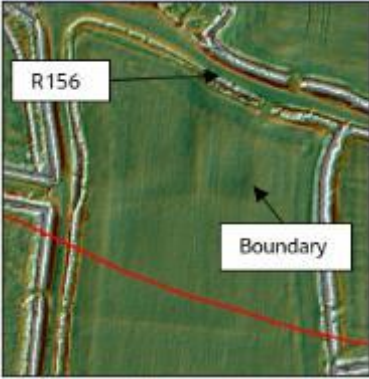
LI_15	695646 / 744405	Blackhall Big	Boundary	<ul style="list-style-type: none">- An ephemeral sub-rectangular feature measuring approximately 32m in with to the south of the R156. Other linear features were noted adjacent to the feature.- Not visible on aerial imagery.- A small group of roadside buildings and a boundary feature are depicted on historic Ordnance Survey mapping in this location (1837). The buildings and boundaries are not depicted on later mapping (1911).- Interpreted as a post-medieval boundary.		Medium	<div>

<p>Simple Local Relief Model (50% transparency) over Single Direction Hillshade Model: DTM azimuth 315° and altitude 10°.</p></div>
LI_16	696120 / 744277	Staffordstown Little	Field system	<ul style="list-style-type: none">- A network of linear features, defining a large area, with some ephemeral linear features within.- Visible on aerial imagery (GoogleEarth 03/2022) to the south of the R156.- Correspond with field boundaries depicted on historic Ordnance Survey mapping (1837, 1911).- Interpreted as former field boundaries forming part of a post-medieval field system.	-	High	<div>

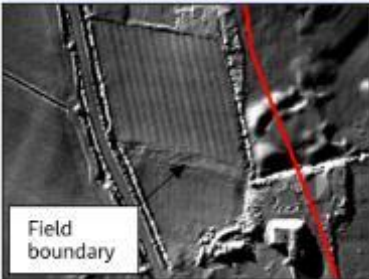
</div> <div>Single Direction Hillshade Model: DTM azimuth 315° and altitude 10°.</div>
LI_51	712584 / 745451	Skephubble	Field boundary	<ul style="list-style-type: none">- A curvi-linear feature measuring approximately 78m in length extending between two extant field boundaries.- Visible on aerial imagery.- Corresponds with a field boundary on historic Ordnance Survey mapping (1843), and later editions depicted the feature as a ditch (1908). The boundary has been removed by the last edition (1941).	-	High	<div>

</div> <div>Single Direction Hillshade Model: DTM azimuth 315° and altitude 10°.</div>

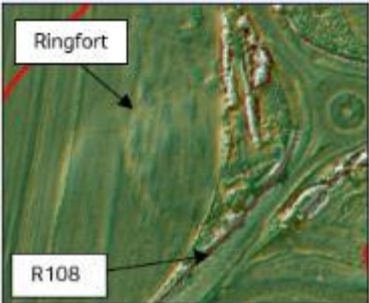
LI_52	715306 / 744689	Forest Great	Ringfort	<ul style="list-style-type: none">- A circular feature measuring approximately 80m in diameter, truncated by a roundabout on the R108.- Corresponds with a ringfort identified on the RMP (AY_41; DU011-043).- The 'fort' is depicted on historic Ordnance Survey mapping (1843, 1908).- This feature is also visible on aerial imagery (GoogleEarth, various; https://ncap.org.uk/frame/11-1-2-76-41, https://ncap.org.uk/frame/11-1-2-76-42).	AY_41 (DU011-043)	High	<div>

</div> <div>Simple Local Relief Model (50% transparency) over Single Direction Hillshade Model: DTM azimuth 315° and altitude 10°.</div>
LI_53	715459 / 744655	Forest Great	Enclosure	<ul style="list-style-type: none">- A sub-circular area of rough ground measuring approximately 30m across south of Naul Road. A possible section of bank is located to the north and west. Appears to have been truncated to the south.- Not depicted on historic Ordnance Survey mapping.- Visible on aerial imagery (and Google Street View) as a slightly raised area of rough ground.- Tentatively interpreted as a possible enclosure of unknown date and function.	-	Low	<div>

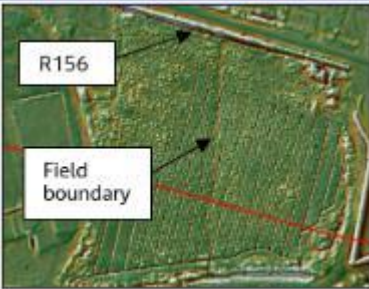
<p>Single Direction Hillshade Model: DTM azimuth 315° and altitude 45°.</p></div>
LI_61	694594 / 744981	Lynaghstown	Field boundary	<ul style="list-style-type: none">- A linear feature measuring approximately 118m in length and orientated north-south located within a field currently in use for plantation, south of the R156.- Visible on aerial imagery.- Corresponds with a field boundary depicted on historic Ordnance Survey mapping (1837; 1911).	-	High	<div>

<p>Simple Local Relief Model (50% transparency) over Single Direction Hillshade Model: DTM azimuth 315° and altitude 10°.</p></div>

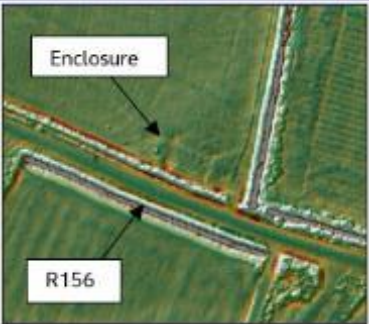
</div> <p>Simple Local Relief Model (50% transparency) over Single Direction Hillshade Model: DTM azimuth 315° and altitude 10°.</p>
LI_63	696778 / 744130	Harlockstown	Enclosure	<ul style="list-style-type: none">- A negative rectangular feature measuring approximately 18m by 10m located within a field, north of the R156. Two adjoining linear features are visible extending from the corners of the enclosure suggesting it may be part of a larger complex.- Visible on aerial imagery.- No corresponding features on historic Ordnance Survey mapping.- Tentatively interpreted as a small rectangular enclosure of unknown date.	-	Low	<div>

</div> <p>Simple Local Relief Model (50% transparency) over Single Direction Hillshade Model: DTM azimuth 315° and altitude 10°.</p>

Image 4.7: A rectangular feature (LI_63), defined by an enclosing ditch, measuring approximately 18m by 10m. Interpreted as a small rectangular enclosure of unknown date in the townland of Harlockstown. Two adjoining linear features, possible ditches, are visible extending from the corners of the enclosure suggesting it may be part of a larger complex.

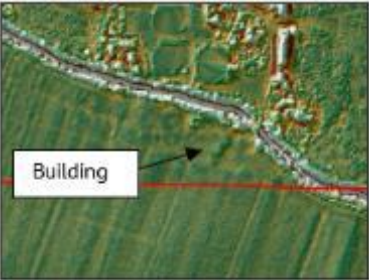
LI_64	697200 / 743953	Waynestown	Building	<ul style="list-style-type: none">- A small sub-rectangular feature, orientated roughly north-south, measuring approximately 14m by 5m.- Vaguely perceptible on aerial imagery (GoogleEarth, 06/2018).- No corresponding features on historic Ordnance Survey mapping.- Tentatively interpreted as a possible building of unknown date; however, could equally be modern disturbance.	-	Low	<div>

</div> <p>Simple Local Relief Model (50% transparency) over Single Direction Hillshade Model: DTM azimuth 315° and altitude 10°.</p>
LI_65	697728 / 744108	Vesingtown	Enclosure	<ul style="list-style-type: none">- An ephemeral circular feature measuring approximately 17m in diameter, located within an agricultural field to the north of the R156.- Not visible on aerial imagery.- No corresponding features on historic Ordnance Survey mapping.- Tentatively interpreted as a possible enclosure of unknown date.	-	Low	<div>

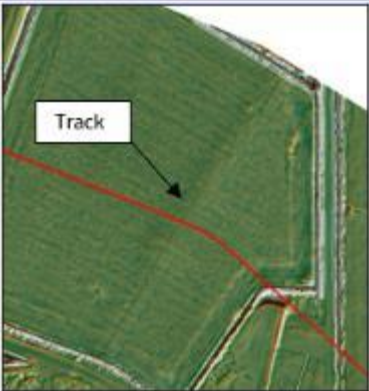
Unique Reference Number	Easting / Northing	Townland	Site Type	Summary Description	Constraint Reference Number (if applicable)	Confidence Rating	Figure
LI_66	699779 / 743165	Cushinstown	Track	<ul style="list-style-type: none">- A pair of parallel linear features measuring approximately 180m in length, orientated roughly north-south located within an agricultural field.- Visible on aerial imagery.- No corresponding features on historic Ordnance Survey mapping.- Interpreted as a possible track of unknown date.	-	Medium	<div>

<p>Simple Local Relief Model (50% transparency) over Single Direction Hillshade Model: DTM azimuth 315° and altitude 10°.</p></div>
LI_67	700753 / 743052	Dunboyne	Boundary	<ul style="list-style-type: none">- A pair of parallel linear features measuring approximately >185m in length (extending outside the Study Area), orientated roughly north-west to south-east located within an agricultural field.- Field known as 'Weld Fields / Wild Fields' (Meath Field Names Project, 2019).- Visible on aerial imagery.- Correspond with a boundary feature on historic Ordnance Survey mapping (1837), with later mapping showing the boundary as a belt of trees (1911).	-	High	<div>

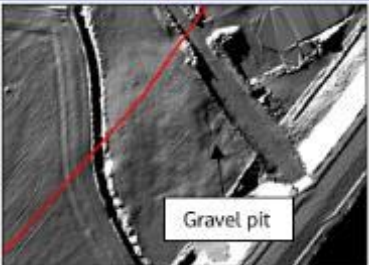
LI_68	701057 / 743391	Dunboyne	Gravel pit	<ul style="list-style-type: none">- An irregular area measuring approximately 16m across located in an area of rough ground south of Kennedy Road.- A possible gravel pit is depicted on historic Ordnance Survey mapping (1837, 1911).- Interpreted as a possible post-medieval gravel pit.	-	Medium	<div>

<p>Single Direction Hillshade Model: DTM azimuth 315° and altitude 10°.</p></div>
LI_69	701568 / 744101	Pace	Palaeochannel	<ul style="list-style-type: none">- A narrow sinuous curvi-linear feature within an area of rough ground north-east of the River Tolka.- Not visible on aerial imagery.- Located within an area of alluvium (Geological Survey of Ireland, n.d.).- The meandering course of the river is depicted on historic Ordnance Survey mapping (1837), then later shown as straightened (1911) with the former channel still depicted.- Interpreted as the former channel of the River Tolka.	-	High	<div>

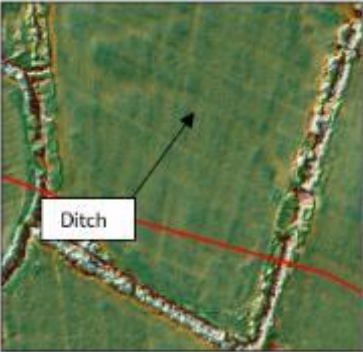
Unique Reference Number	Easting / Northing	Townland	Site Type	Summary Description	Constraint Reference Number (if applicable)	Confidence Rating	Figure
LI_70	708628 / 743753	Spicklestown	Ditch	<ul style="list-style-type: none">- A negative curvi-linear feature measuring approximately 103m in length, within an agricultural field in DL_05.- Visible on aerial imagery.- No corresponding features on historic Ordnance Survey mapping.- Tentatively interpreted as a possible ditch of unknown date.	-	Low	<div>

</div> <div>Simple Local Relief Model (50% transparency) over Single Direction Hillshade Model: DTM azimuth 315° and altitude 10°.</div>
LI_71	712750 / 745244	Ballystrahan	Enclosure	<ul style="list-style-type: none">- A circular area with possible enclosing ditch to north-east. Measuring approximately 27m in diameter, within an agricultural field.- Not visible on aerial imagery.- No corresponding features on historic Ordnance Survey mapping.- Tentatively interpreted as a possible enclosure of unknown date.	-	Low	<div>

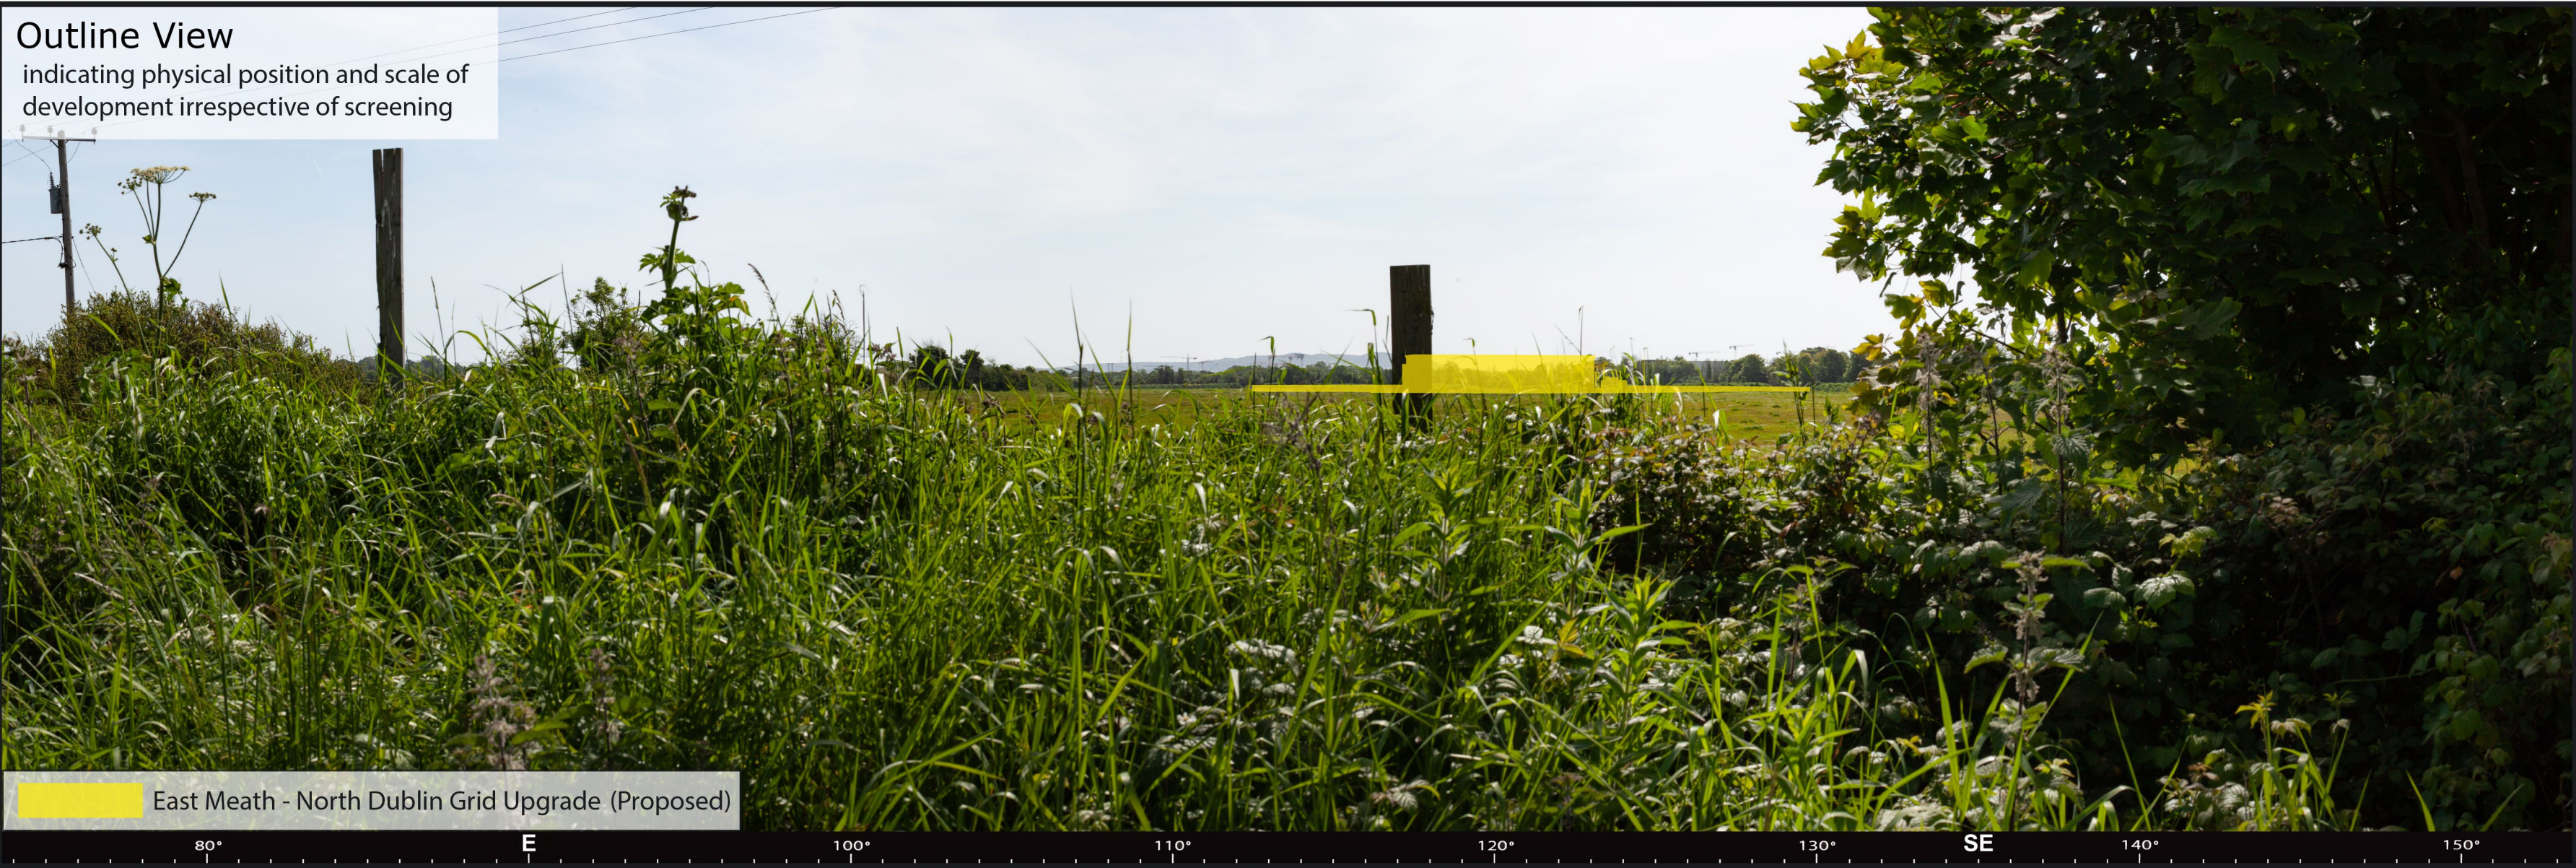
Outline View
indicating physical position and scale of development irrespective of screening

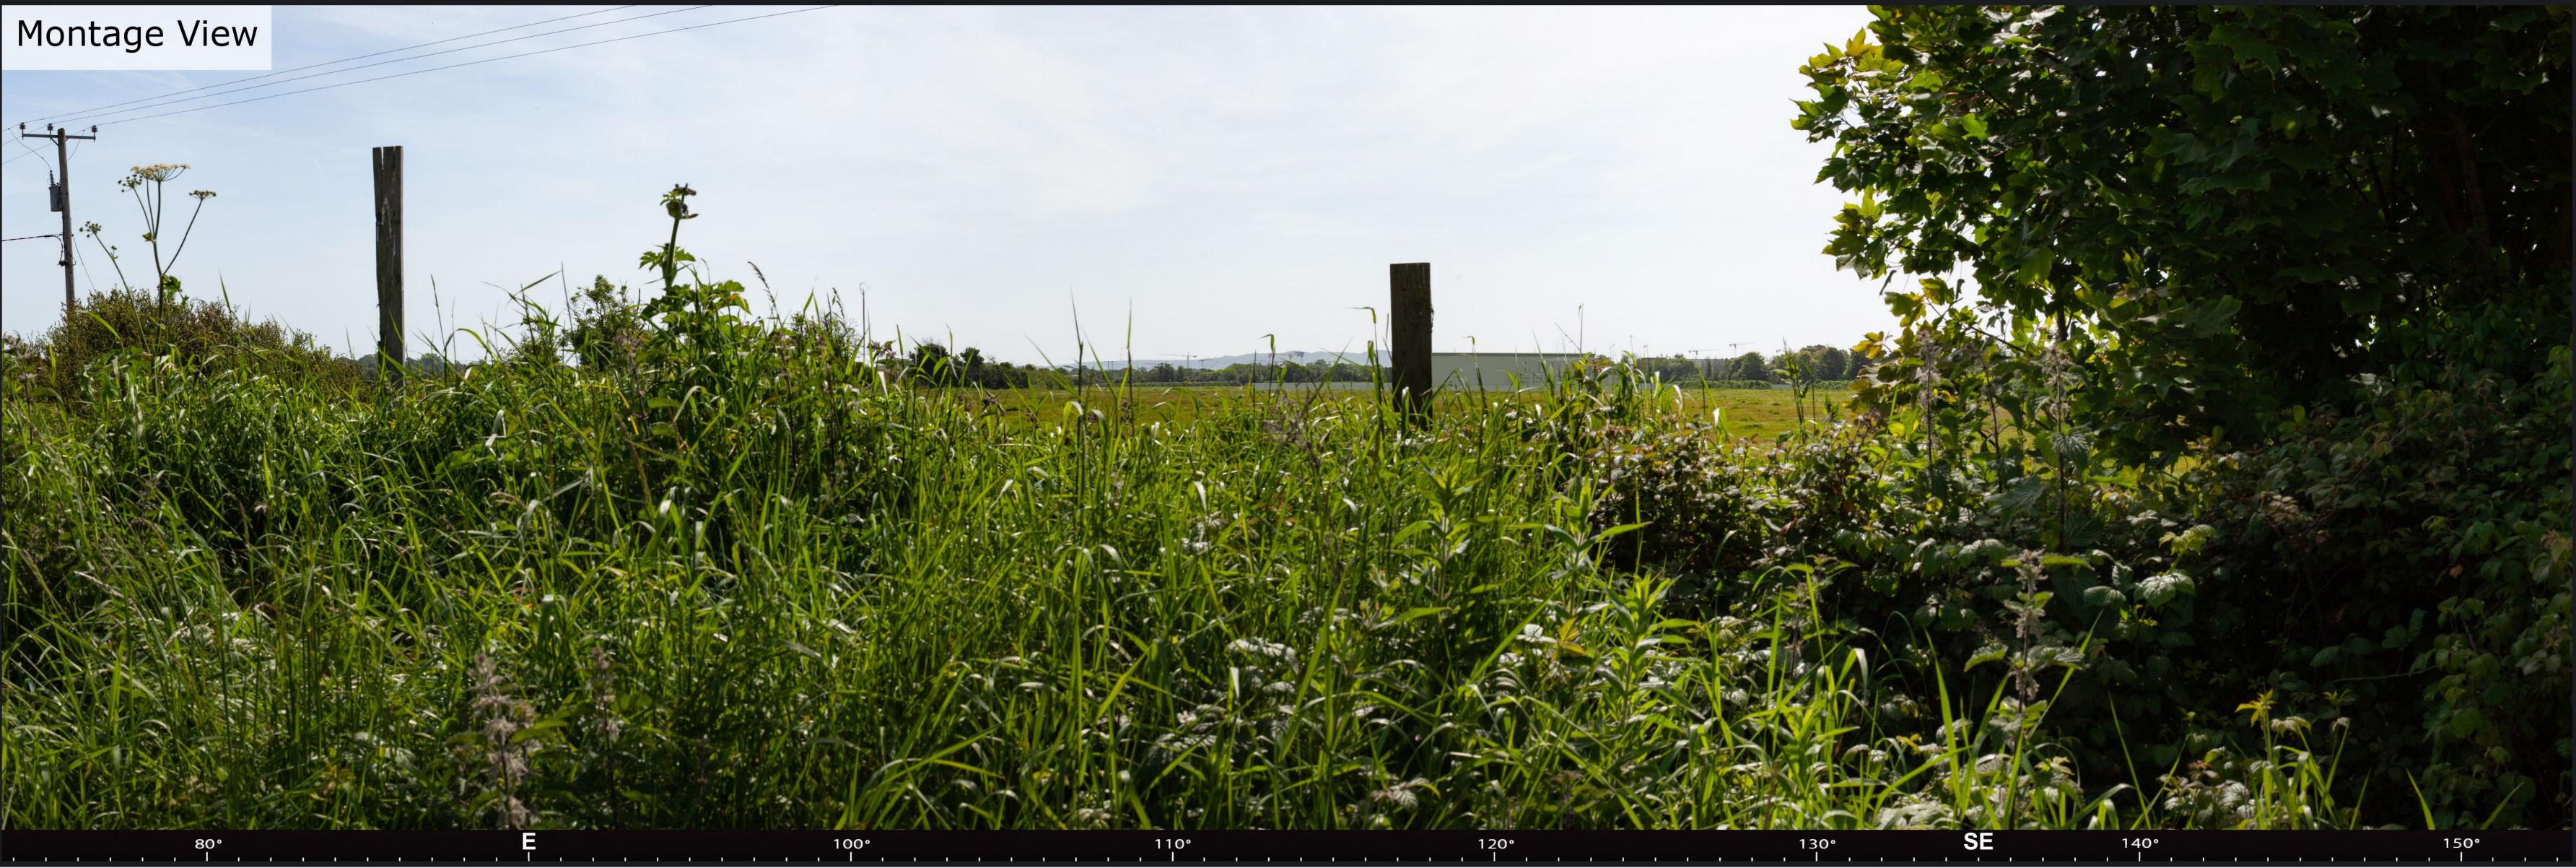
Montage View

These are 80° panoramic montages captured and presented in accordance with the guidance set by the British Landscape Institute 2011 - Advice Note 01/11.

Easting (ITM):	718752	Lens:	50mm / Full Frame Sensor	Date:	29/05/2023
Northing (ITM):	741995	Camera:	Canon 1-D Mark II digital SLR	Time:	10:07
Direction of View	114° E of Grid North	Camera Height:	1.7m Above Ground Level		
Angle of View:	80°

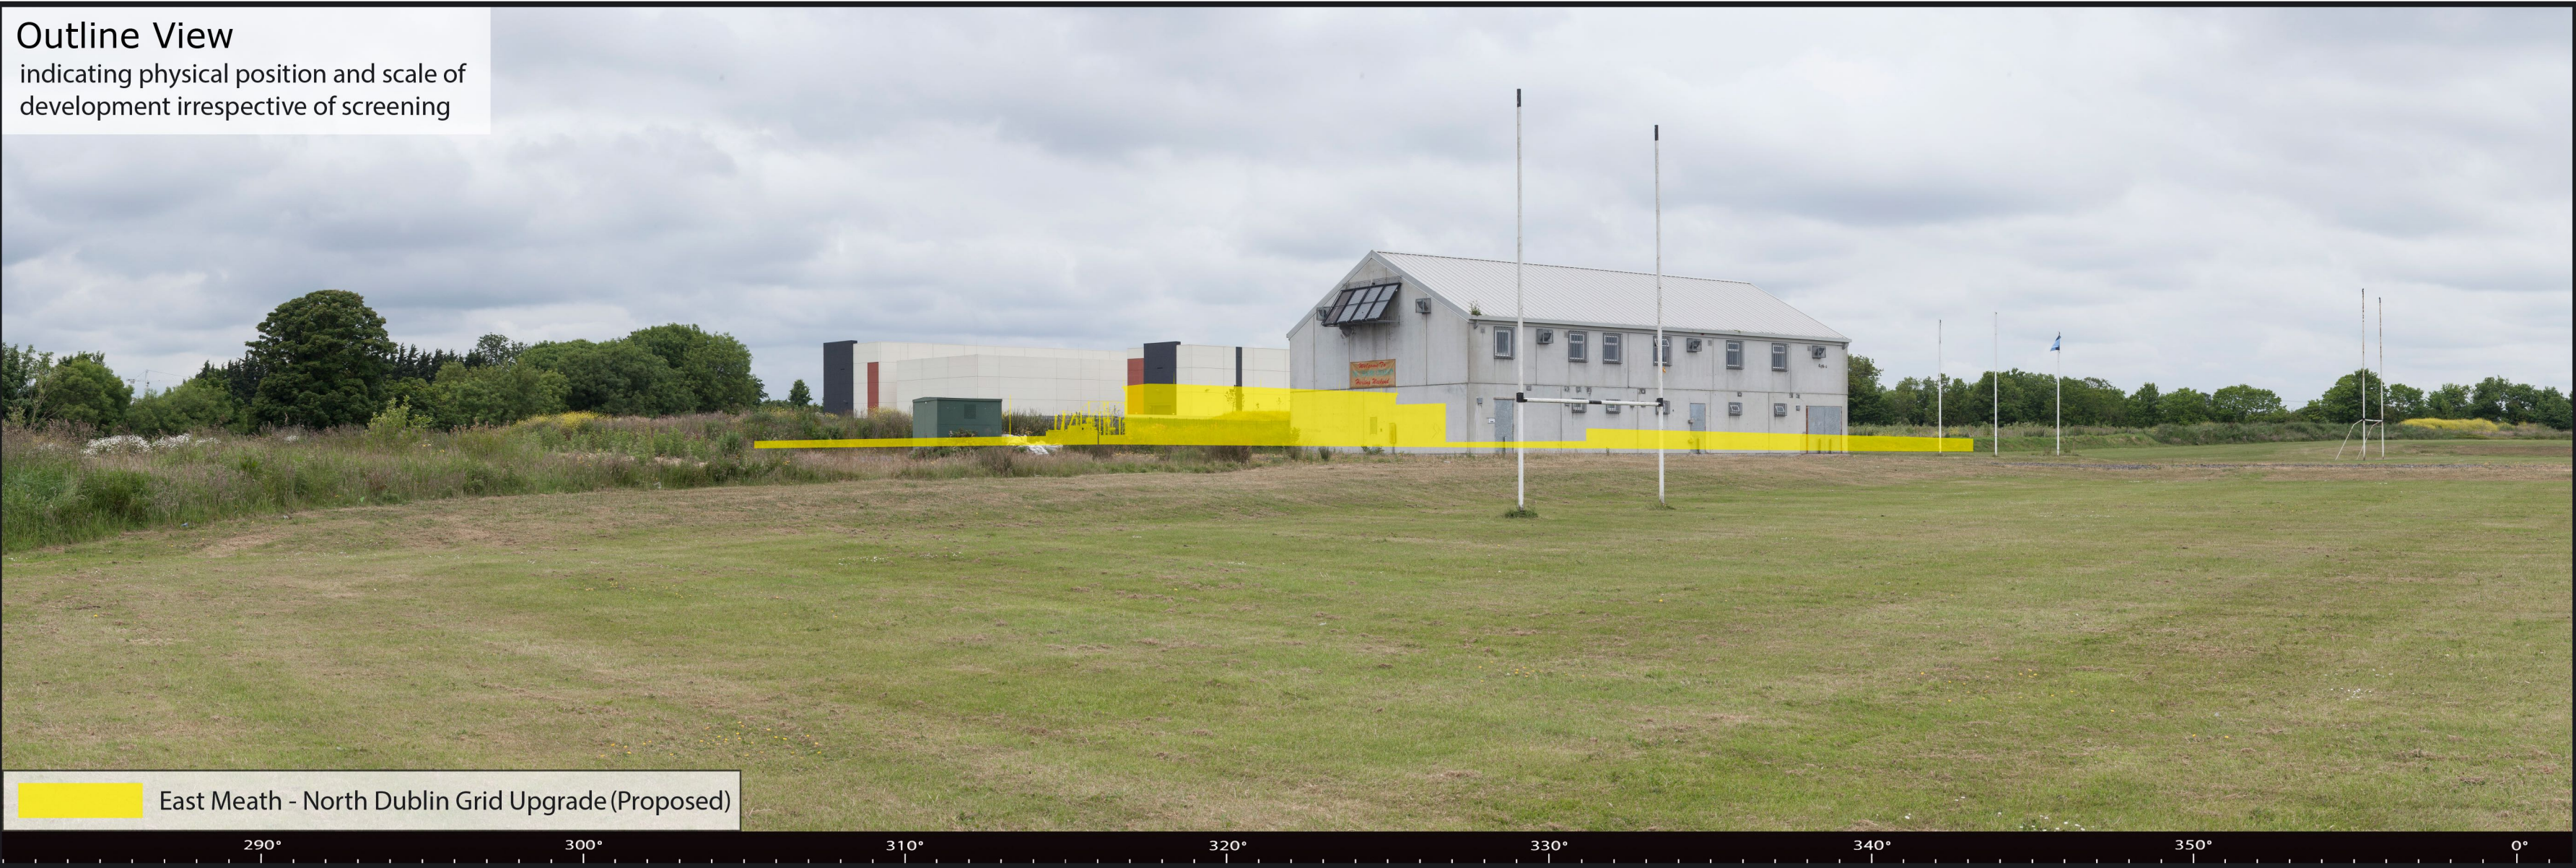
Outline View
indicating physical position and scale of development irrespective of screening

Easting (ITM):	719690	Lens:	50mm / Full Frame Sensor	Date:	12/06/2018
Northing (ITM):	741270	Camera:	Canon 1-D Mark II digital SLR	Time:	10:26
Direction of View	23° E of Grid North	Camera Height:	1.7m Above Ground Level		
Angle of View:	80°
